Appendix A

Reference: STRUCTURAL ASSESSMENT REPORT & RECOMMENDATIONS ONTARIO MUSEUM OF HISTORY & ART ONTARIO, CALIFORNIA [SF PROJECT #14081]

Ontario Museum MEP Condition Assessment Report

Master Plan & Building Assessment

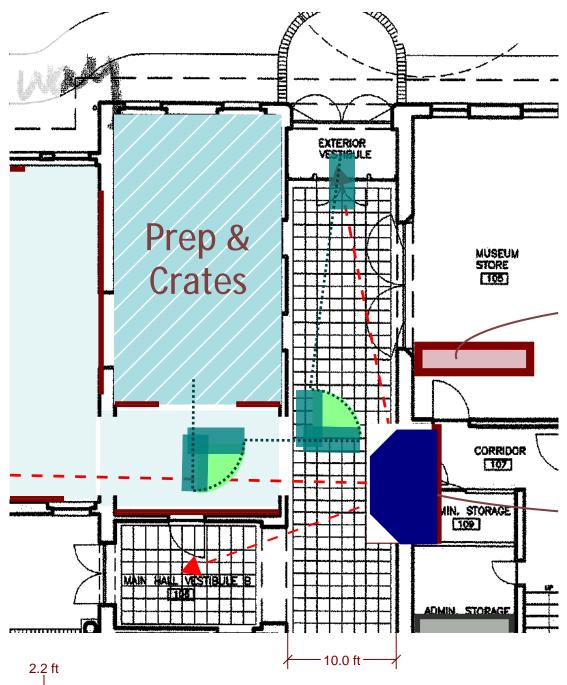
OMHA Pallet Truck Access 29 Oct 2018 ARG/KFrutiger

Per this diagram, a typ pallet truck can be simply maneuvered from the front entry to the proposed prep & crate area. The leading corner of a projecting desk would be tapered to ensure clearance

Typ pallet truck with 4'6" turning radius

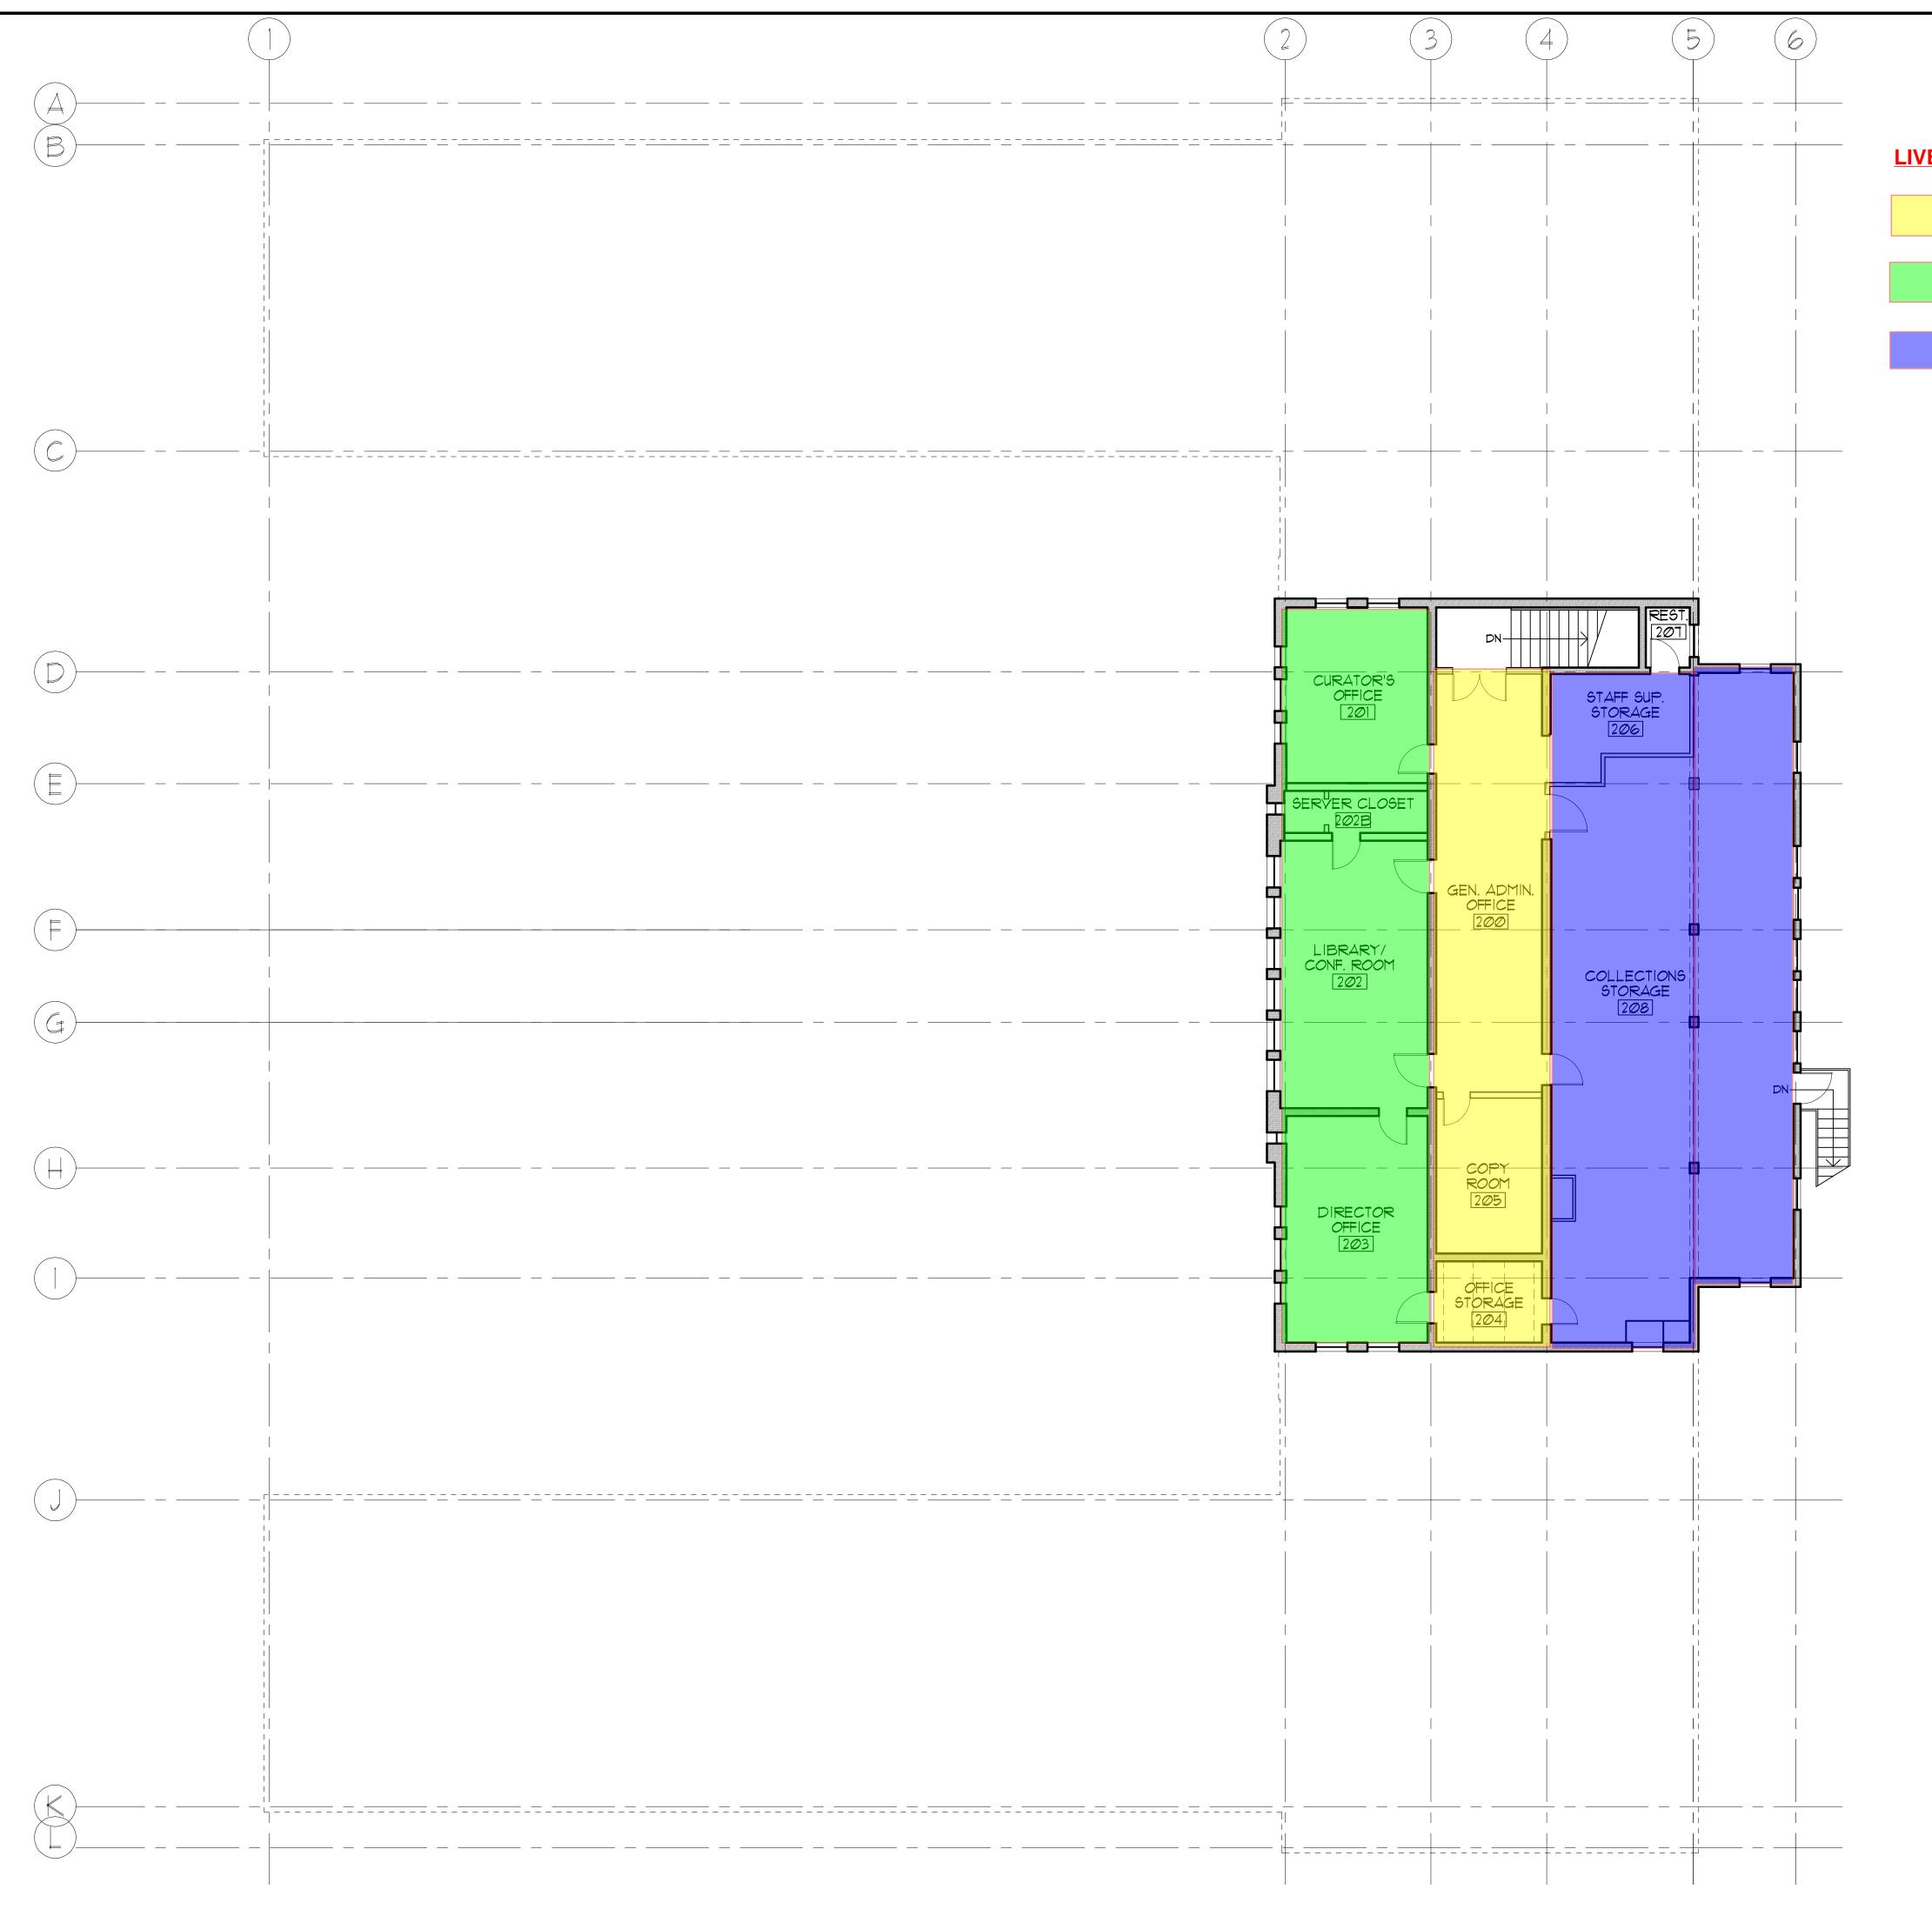
SECOND FLOOR LIVE LOAD RATINGS

Please note, the collections storage area was found to have very limited live load capacity, particularly as a result of limitations on the strengths of beams and girders. This could be a result of engineering analysis methods that have changed since the Museum was designed and constructed. The structure has demonstrated that it can sustain the live loads currently in place; however, we cannot expect the structure to provide additional capacity without conducting targeted materials testing in this area.

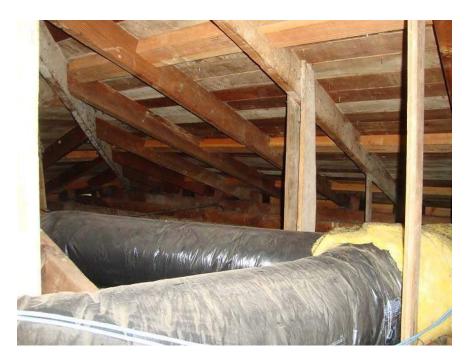
Image 3. Roof framing above second floor. Note straight sheathing.

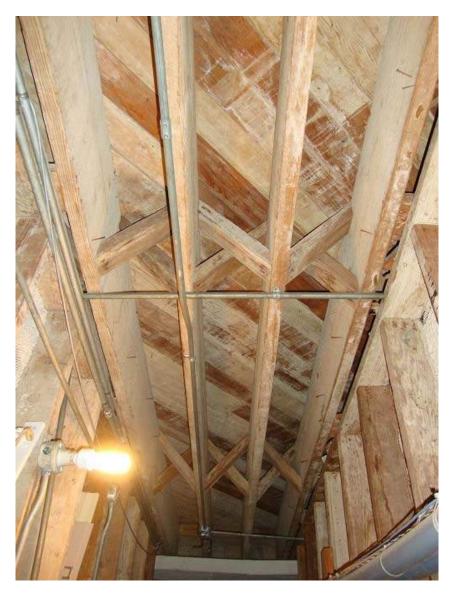
Image 5. Council chambers floor framing viewed from basement, note diagonal sheathing.

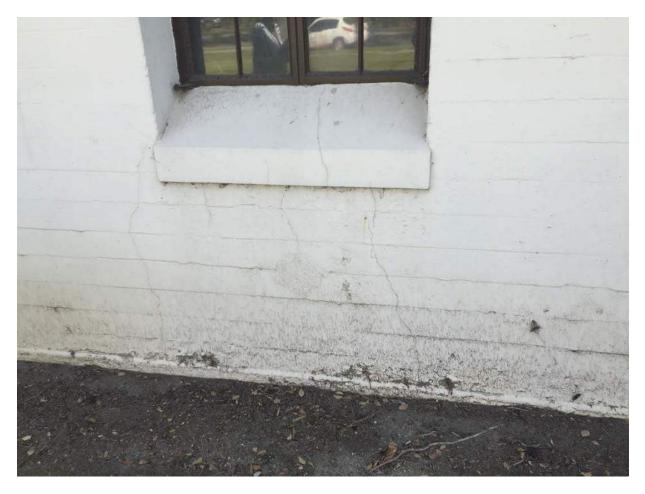
The Ontario Museum is in generally good condition, and shows little indication of prior earthquake damage or significant settlement. Minor cracks were observed along the exterior walls of the north and south wings, frequently occurring below windows extending toward the ground.

We understand there has been concern regarding possible settlement at the west end of the north wing, particularly since local site drainage tends to bring water toward the north end of the building. However, we feel the cracking patterns on the wall of the north elevation are not conclusively a result of building settlement, and are more likely a result of concrete shrinkage over time. Nevertheless, it is important that drainage patterns draw water away from the building to preserve foundation integrity. We understand there is a landscape design development underway, and we do recommend that grade modifications be made that ensure water drains away from the building at all locations.

Image 6. Common crack pattern below exterior window.

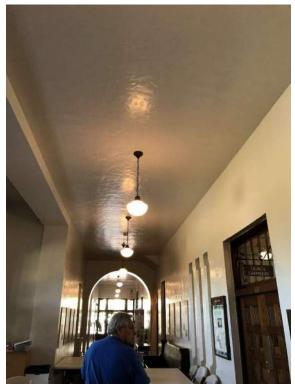
Figure 1 - 1st Floor Corridor Lighting

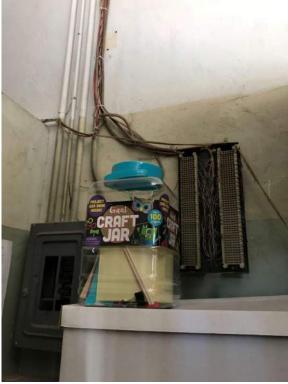
Figure 2 - Panel "G"

It is recommended that all old wiring be removed and modernized as part of the proposed improvements to the building.

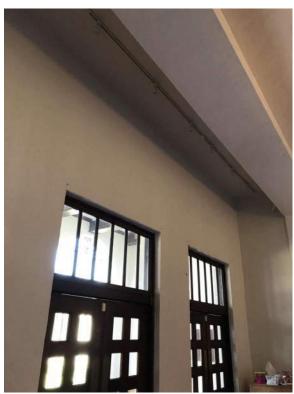
Figure 3 - Sample Missing Exit Sign/Emergency Fixture

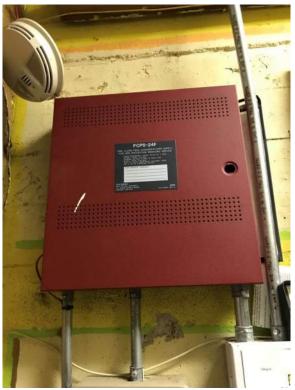
Figure 4 - Missing Fire Alarm Control Panel
