Building Assessment & Master Plan

Ontario Museum of History & Art

City of Ontario CA | March 2019

Architectural
Resources Group

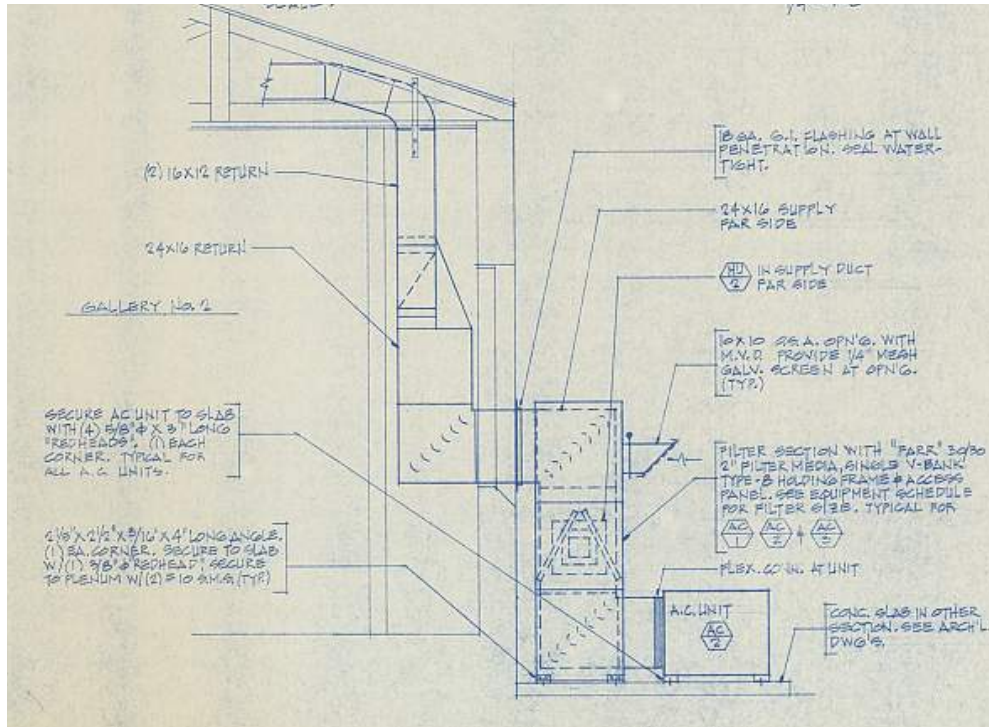
Section detail of existing hard-ducted condition showing undesirable impact on window and interior space

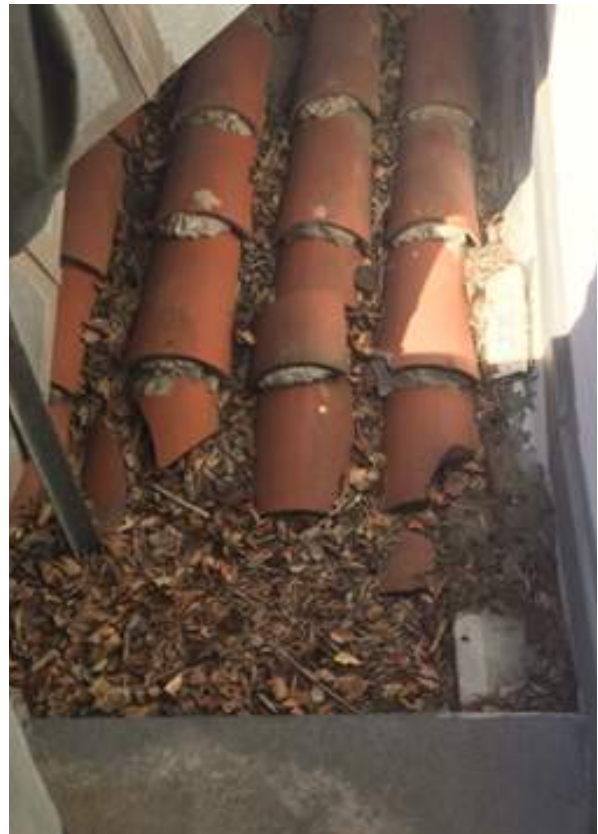
immediately adjacent, and reportedly there is a leak in this location. ARG noted broken tile and heavy accumulations of debris in this area. Sheet metal wall flashing set into a reglet at the concrete wall is visible, but other flashing or waterproofing cannot be observed. Tile and debris removal and further up-close inspection will be needed to confirm the condition of the underlayment and flashings in this area, and determine the leak location. Additional flashing and/or drainage may be required.

View from mechanical pad to clay tile roof at reported leak location. Note broken tile, heavy debris, and flashing.

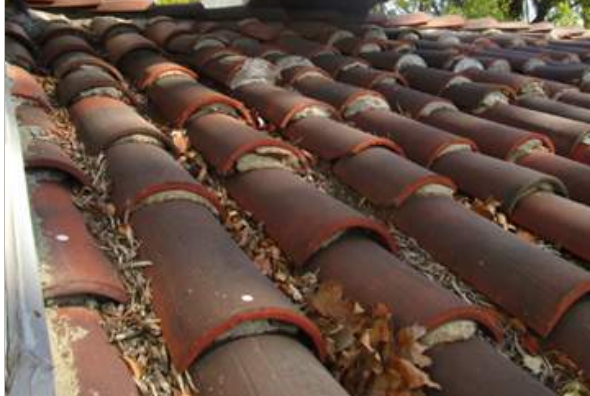
View of clay tile roofing from second floor window; note debris accumulation.

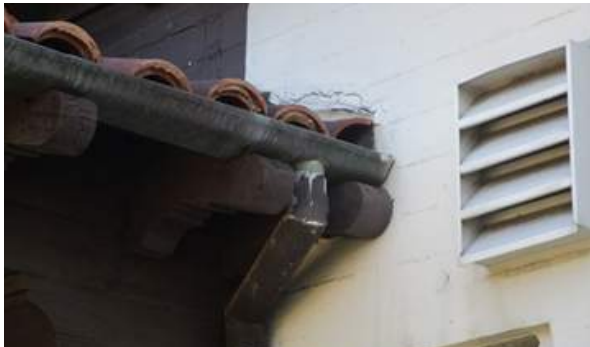
Gutter-to-downspout connection; note drip stains at loose fitting.

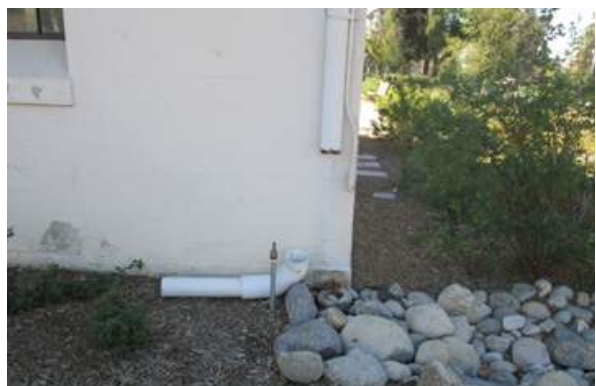
Replacement PVC extension disconnected from downspout at northwest corner of building.

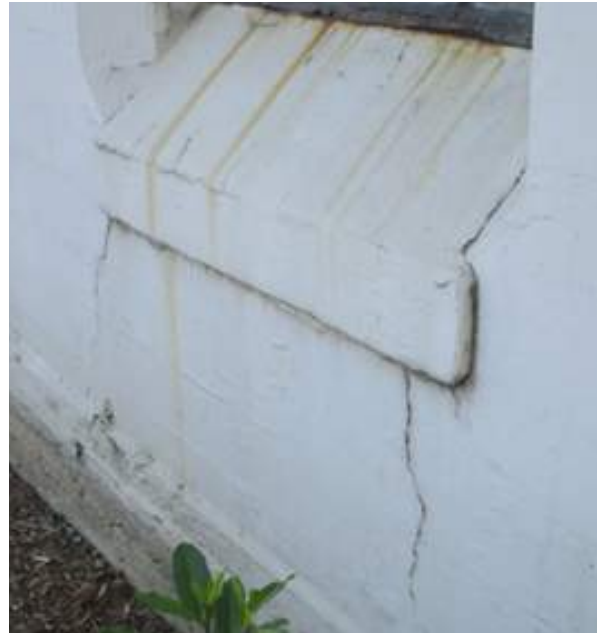
In general, the concrete walls are in good condition. Minor cracks (hairline to 1/16-inch wide) are present throughout. Wider cracks (greater than 1/16-inch) and spalls (material losses) occur in localized areas. The elastomeric coating is generally intact, but peeling in localized areas, particularly near the base of walls. Ferrous stains were also observed from surface runoff from adjacent metals. The tilework is generally in good condition, with some minor cracking of grout joints, paint splatter, and a few missing units.

Cracks in concrete at west elevation.

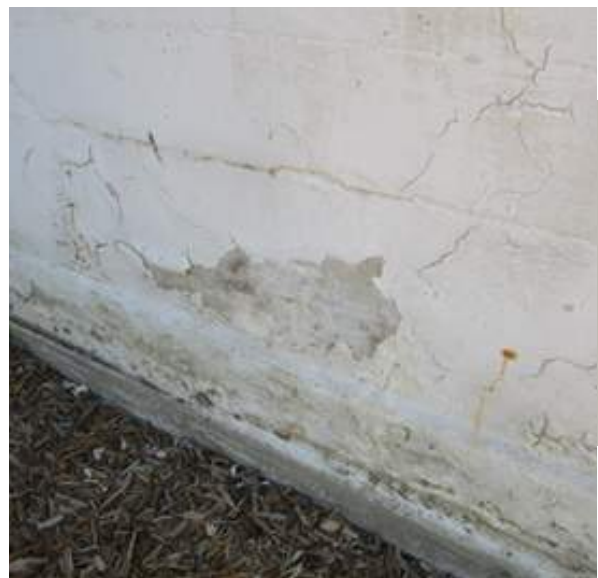
Peeled paint coating at base of wall, west elevation.

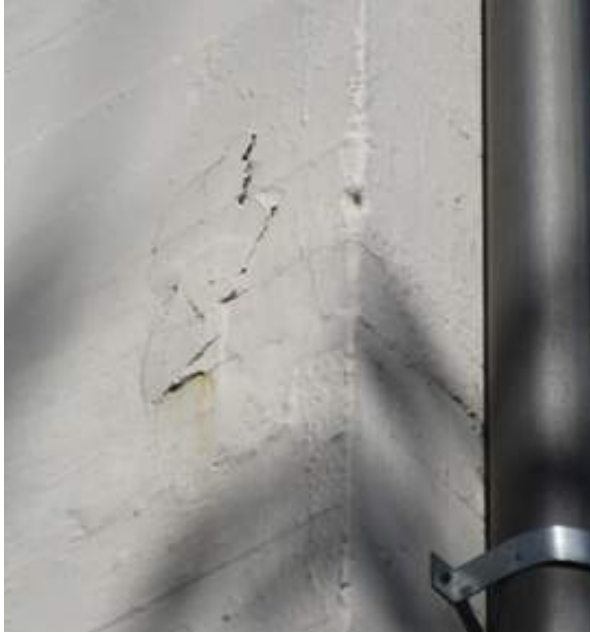
Spalled concrete at east elevation (south return).

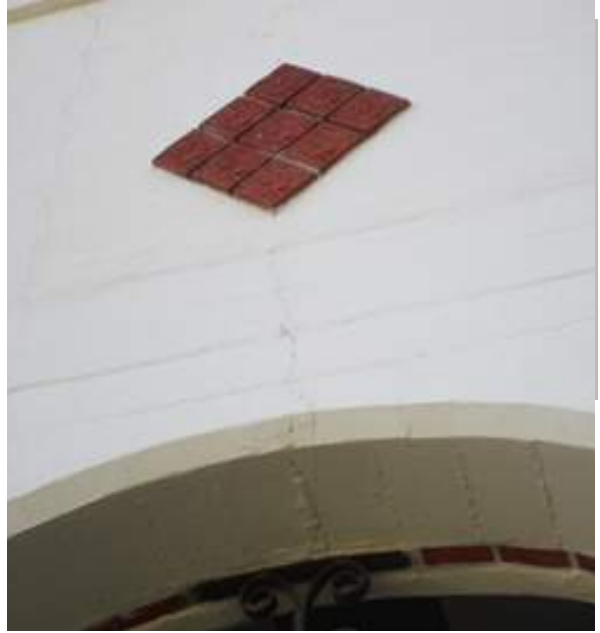
Terra cotta tile details at east courtyard elevation. Note crack at concrete wall and arch below.

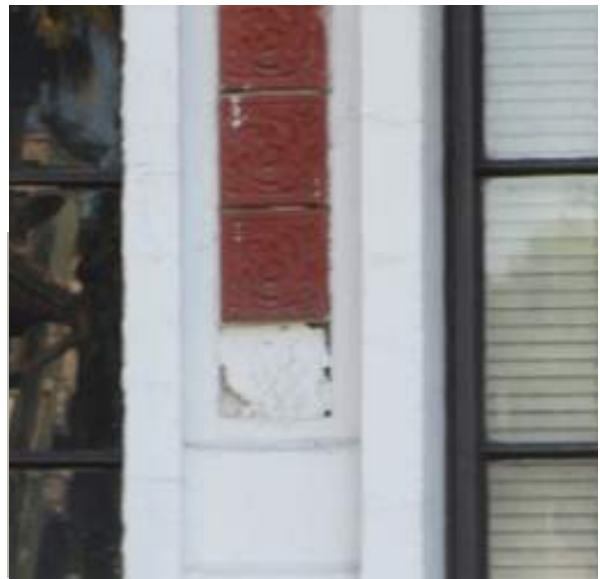
Missing tile between windows at east courtyard elevation.

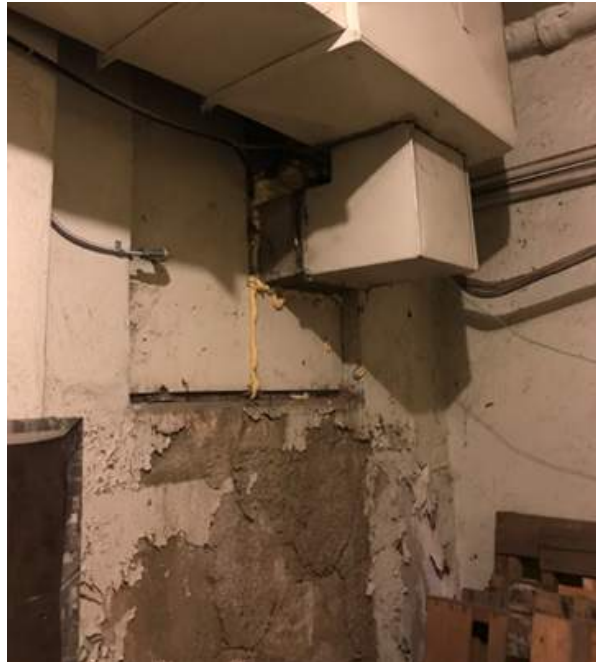
Historically, the basement has been prone to dampness and water infiltration and has not been used for collections storage or other uses requiring environmental control. ARG noted numerous areas of damaged interior finishes and staining consistent with water infiltration through the basement walls. The basement windows are heavily deteriorated and a likely source of some portion of the water infiltration. Most windows have been provisionally closed up with plywood. One window has been infilled with ductwork, with ill-fitting infill panels and poor sealant work. An active water leak has been reported in this location. The wall finishes below this window are heavily deteriorated.

Ductwork installed in basement window opening. Note plywood infill, sealant, and heavy deterioration of wall below.

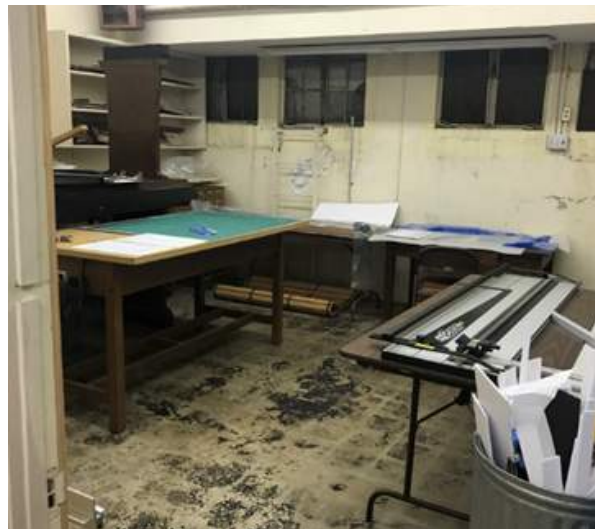
Basement workroom; note vinyl tile has been removed from concrete floor slab.

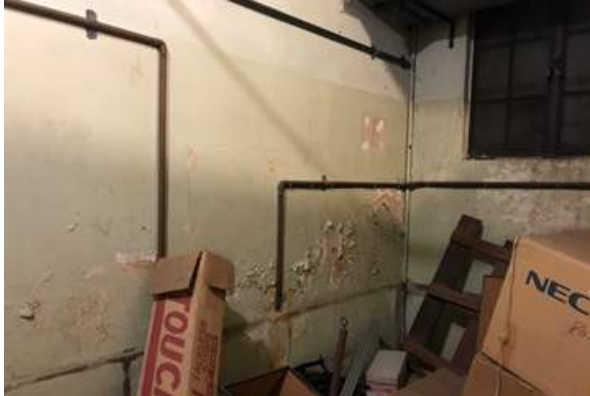
Peeling paint and deteriorated wall finishes at basement storage room.

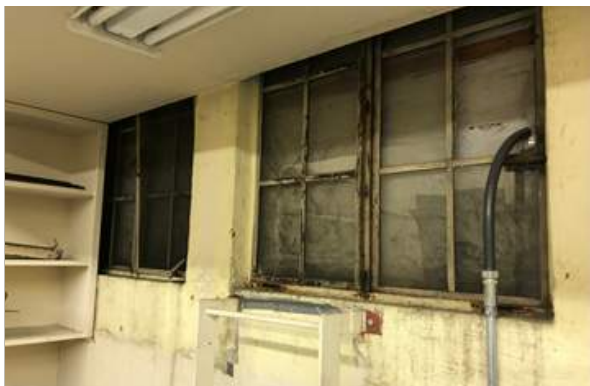
Deteriorated/damaged windows at basement. Windows covered with plywood at exterior.

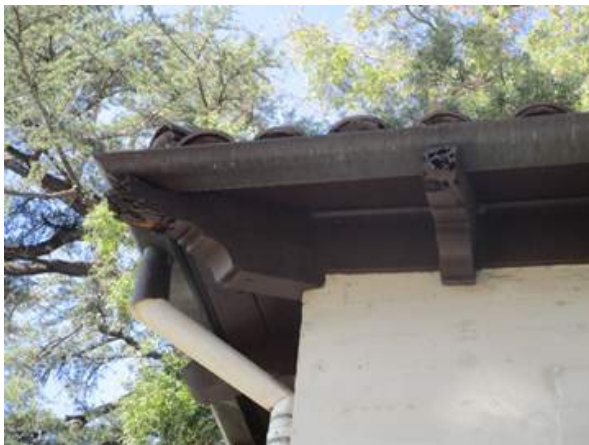
In many locations throughout the building, the ends of the rafter tails are decayed (wood rot). The decay varies from minor splitting and checking to moderate loss (small voids) to heavy decay with large areas of loss. The heavy decay was noted primarily at building corners. ARG was unable to survey the rafter tails up-close to confirm the depth of decay. There may be additional areas of decay immediately below the gutter where the tails are notched.

Typical decayed ends of exposed rafters. (northeast corner shown)

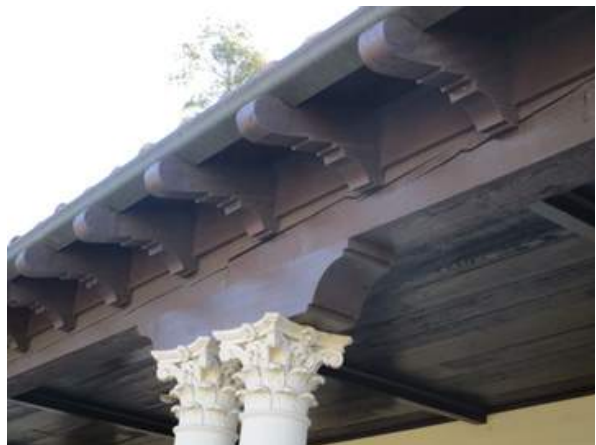
The rafter tails at the verandas are generally in slightly better condition than those elsewhere, likely due to their protective paint coating. The heavy timber beams, on the other hand, are in poor condition, with numerous heavy checks and splits along their length. In some areas, the splits are very deep, almost entirely through the member, with some displacement or racking observed. Further inspection by a structural engineer is recommended.

Typical deep checking/splits at veranda wood beams. (south courtyard elevation shown)

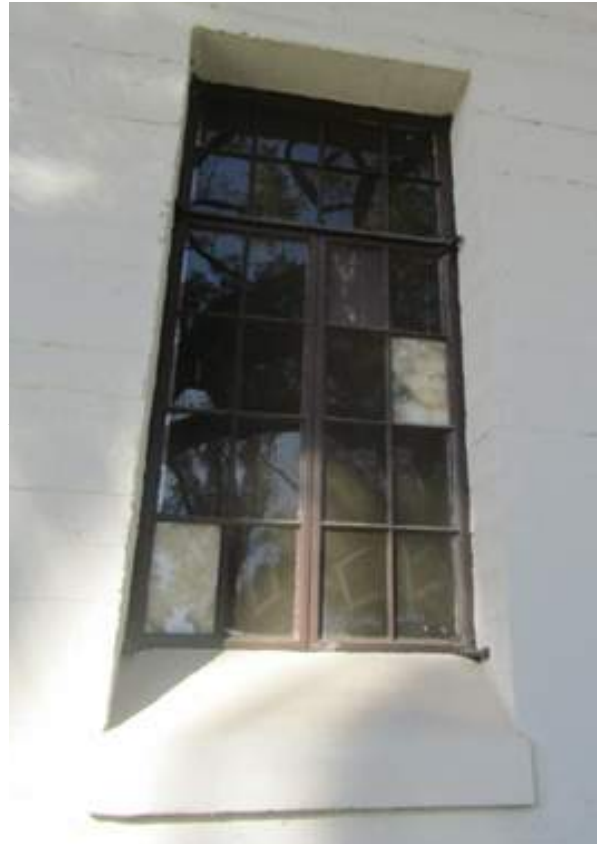
Typical window at gallery blocked with interior partition; note insulation fill and back-painted glass.

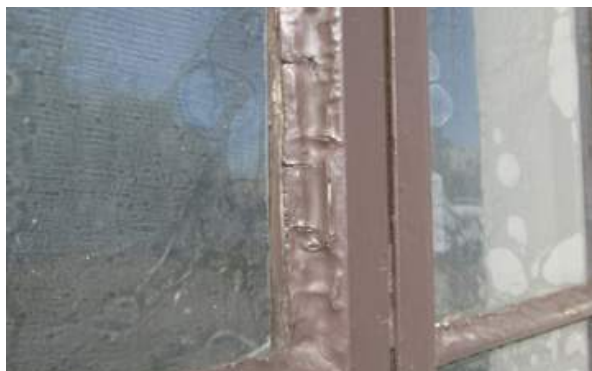
Typical condition at windows requiring basic maintenance; note cracked glazing putty.

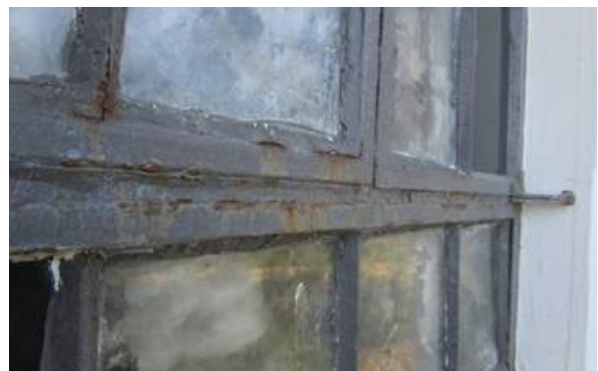
Typical condition at windows requiring more extensive repair; note corrosion of steel components.

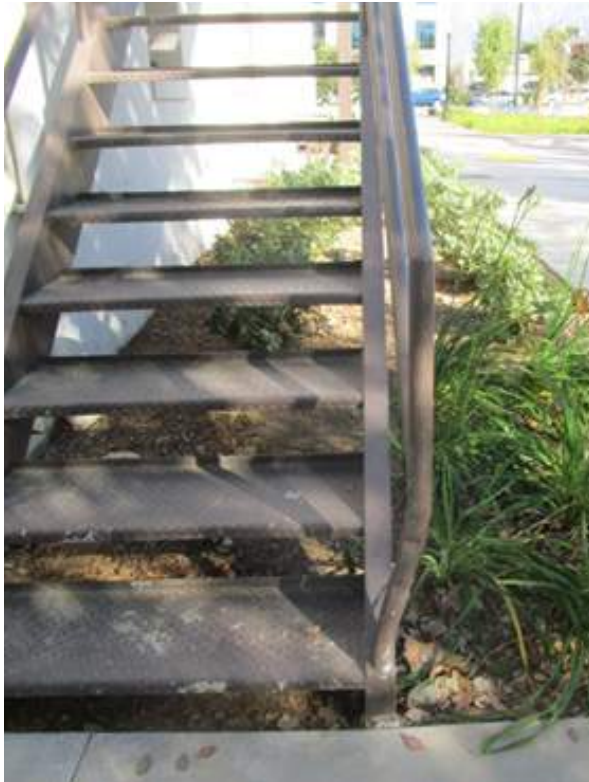
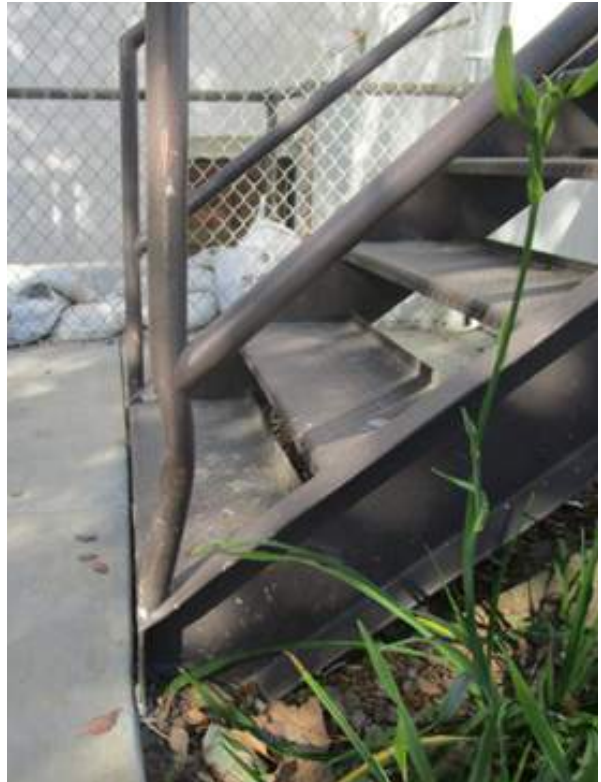
In general, the stair appears to be in good condition; however, some repairs are needed. The painted steel surfaces are weathered, with localized corrosion and peeling paint. Base plates and anchor bolts are similarly corroded. The pipe handrail at the base of the stair has been damaged, reportedly during recent construction activities.

View of steel stair; note damaged rail post.

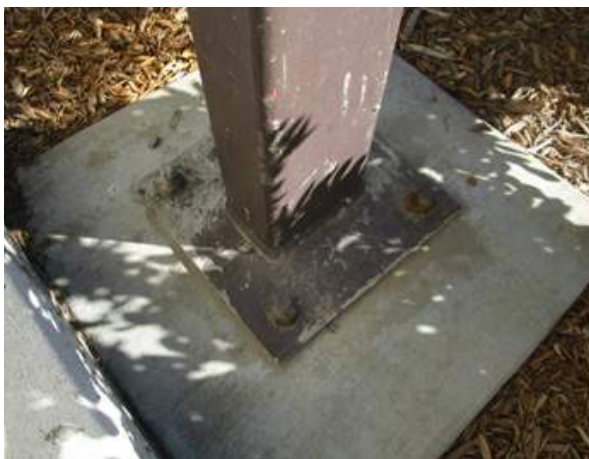
Base plate at steel column support; note corrosion at anchor bolts.

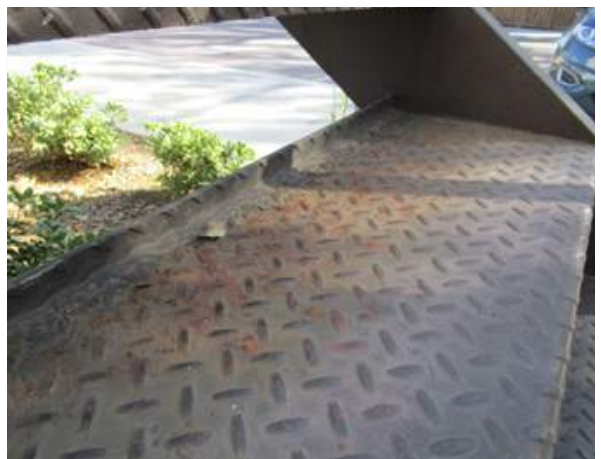
Checker-plate steel stair tread; note surface corrosion and peeling paint.

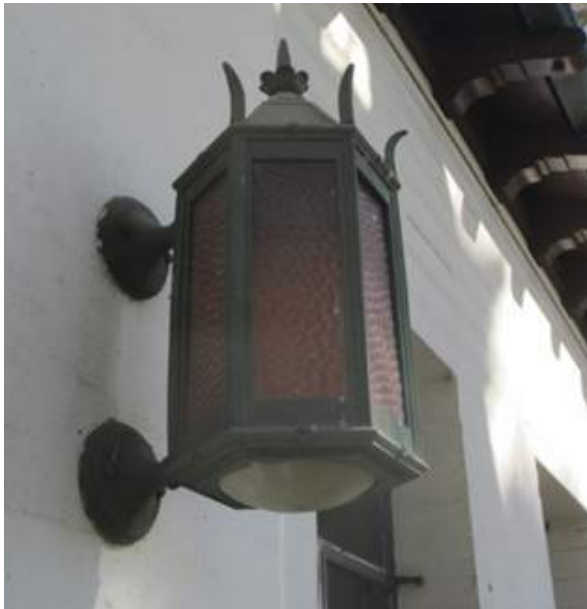
Bronze sconce at exterior entrance, south elevation; note heavy soiling.

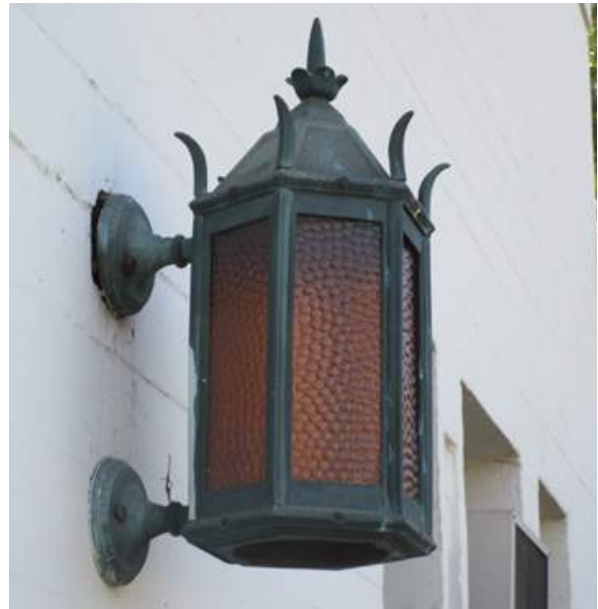
Bronze sconce at exterior entrance, east courtyard elevation; note missing lens at bottom, missing fasteners and localized corrosion products (green).

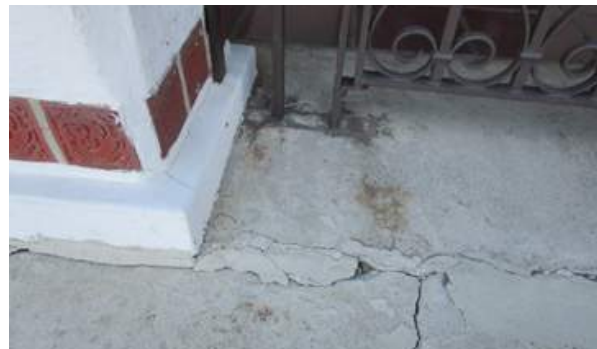
the cracks have been previously repaired with cementitious repair materials; however, the repairs have failed in most areas. At entrances with decorative gates, the gate frames and hardware are typically corroded where in contact with concrete, resulting in ferrous staining, cracking and spalling of the concrete. Other ferrous staining was noted at areas where signage or other objects were placed on the concrete.

Detail view of damaged concrete.

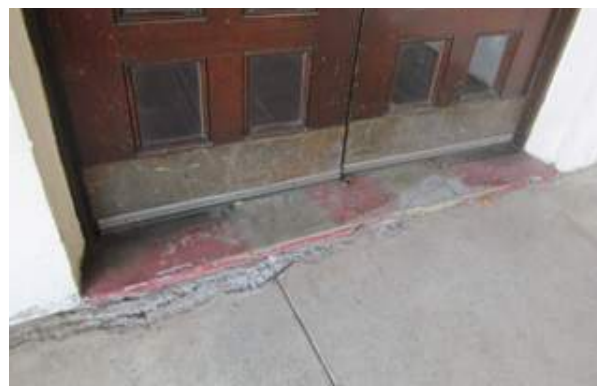
Typical concrete spalling at entrance thresholds, north and south courtyard elevations.

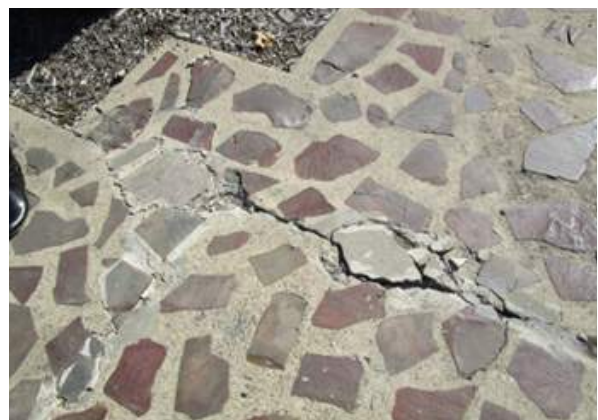
Cracking and spalling at slate paver walkway.

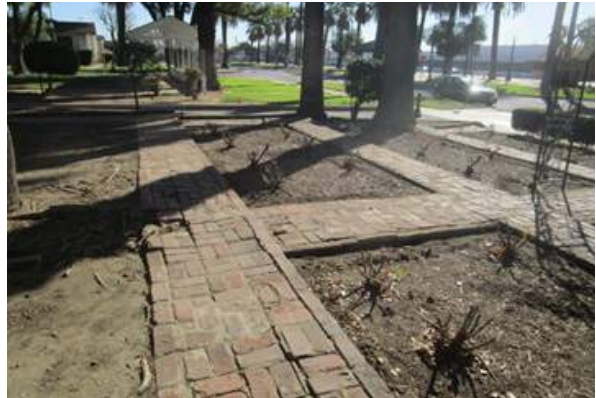
The brick paver walkways are generally in fair to poor condition. The terraced site is eroded, with differential settlement throughout. The walkway surfaces are generally uneven, with some areas lifted by invasive root systems and others depressed from settlement and soil erosion. The damage and displacement appears to be worse nearest the building; the lower terraced walkways are in somewhat better condition. In one area, tree roots have heavily damaged the walkway, and portions of brick are missing. Mortar joints between units are typically eroded and cracked. Some individual bricks are loose from the setting bed. Others are eroded and spalled at the face. Loose bricks have reportedly been used as projectiles to damage the museum building. At the end of one walkway adjacent to the building, there are the remains of a concrete bench; only the two support legs remain, the seat portion is no longer extant.

Damaged brick pavers at rose garden.

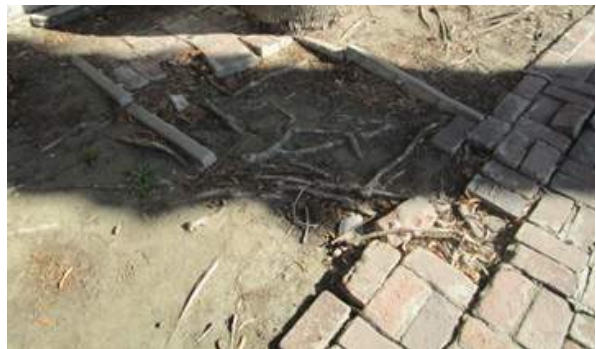
Walkway extension with missing brick pavers and tree root damage.

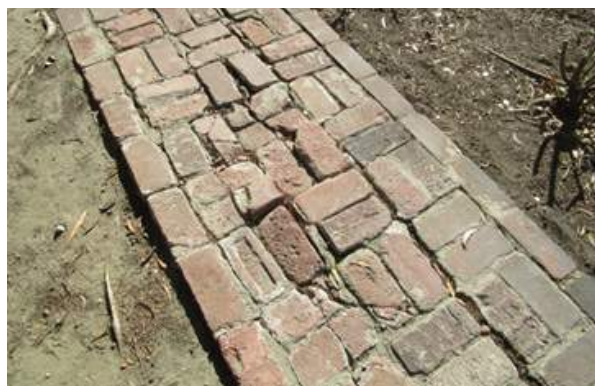
Uneven/deteriorated brick pavers and mortar joints.
